Appendix A
Illustrations: Existing Condition
Photographs with Key Plan

Preservation Plan
First Unitarian Society of Plainfield
724 Park Avenue
Plainfield, New Jersey 07060

PHOTO KEY

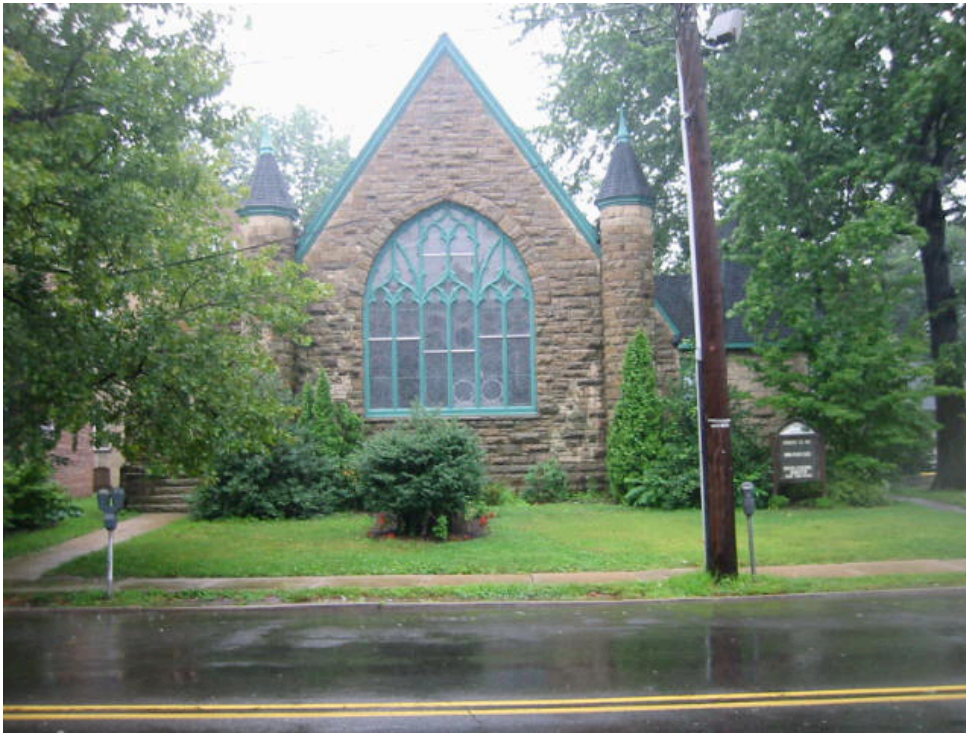
Photograph #1: East Elevation of the Church showing the Robinson window which dominates the Park Avenue elevation and is flanked with towers to the north and south.

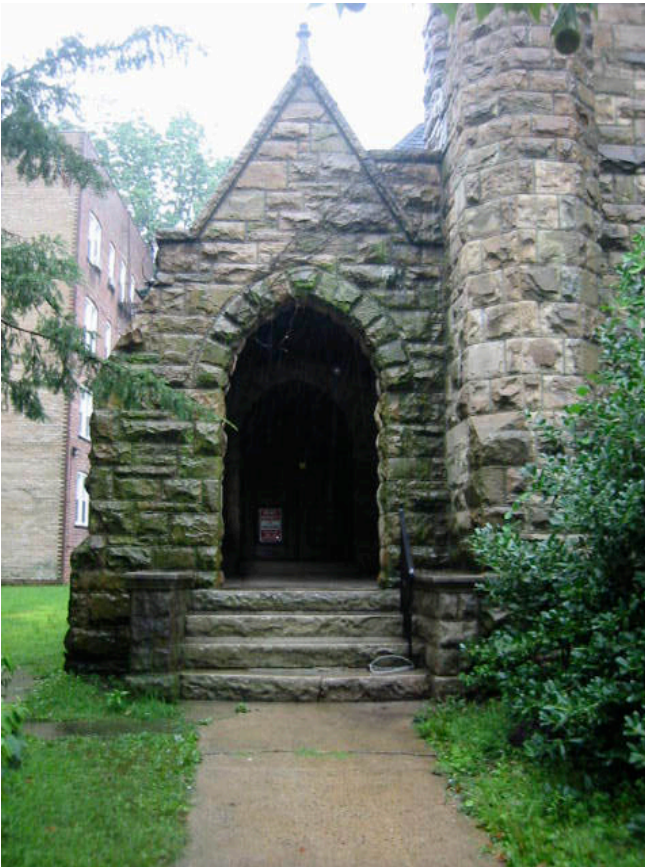
Photograph #2: Detail at East Elevation of Church showing the original main Church Entrance to the south. This covered porch area is paved with bluestone. There is a wood beaded board ceiling that matches the doors leading into the original Church Lobby. Note the rusticated, rough-cut surface finish of the random-laid stone.

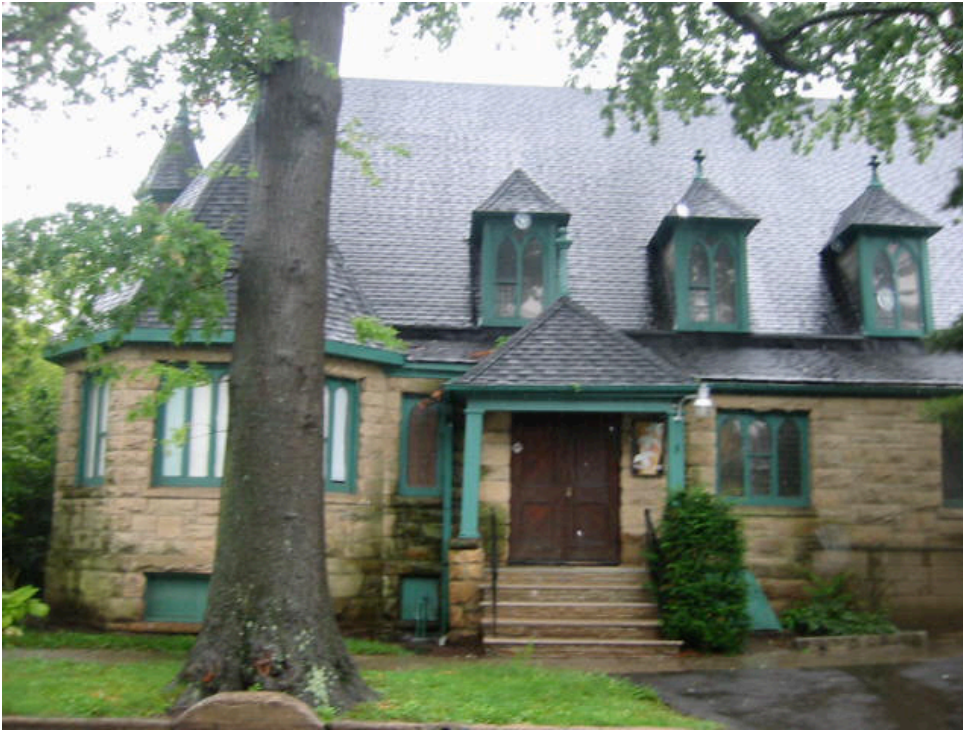
Photograph #3: North Elevation of the Church. Most notable are the three dormer windows with their decorative metal finials, (the third finial is missing). The Church's north facing entry area with its asphalt shingled hip porch roof. To the east is the octagonal shaped room that houses the minister's office. In the original Church, this area was called the "Ladies Parlor" and there was a kitchen located in the basement below.

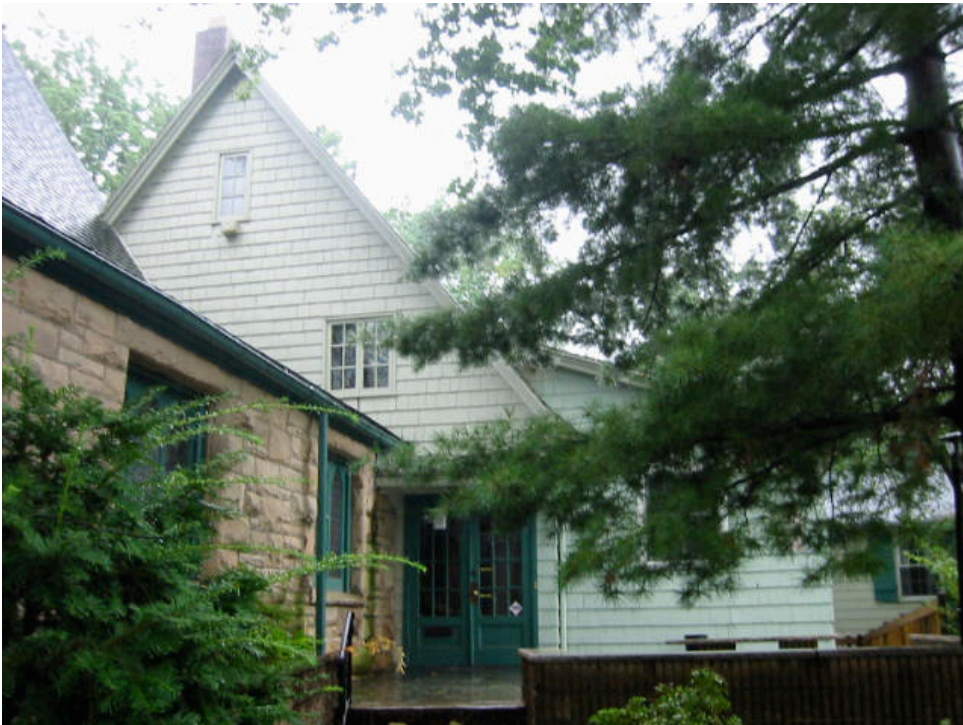
Photograph #4: East facing Elevation of the Parish Hall. Notable are the wooden casement windows, wood shingle siding, and the east facing covered entrance. Also note the he excessive plant material that is surrounding the building and the masonry wall surrounding the raised terrace at this entrance.

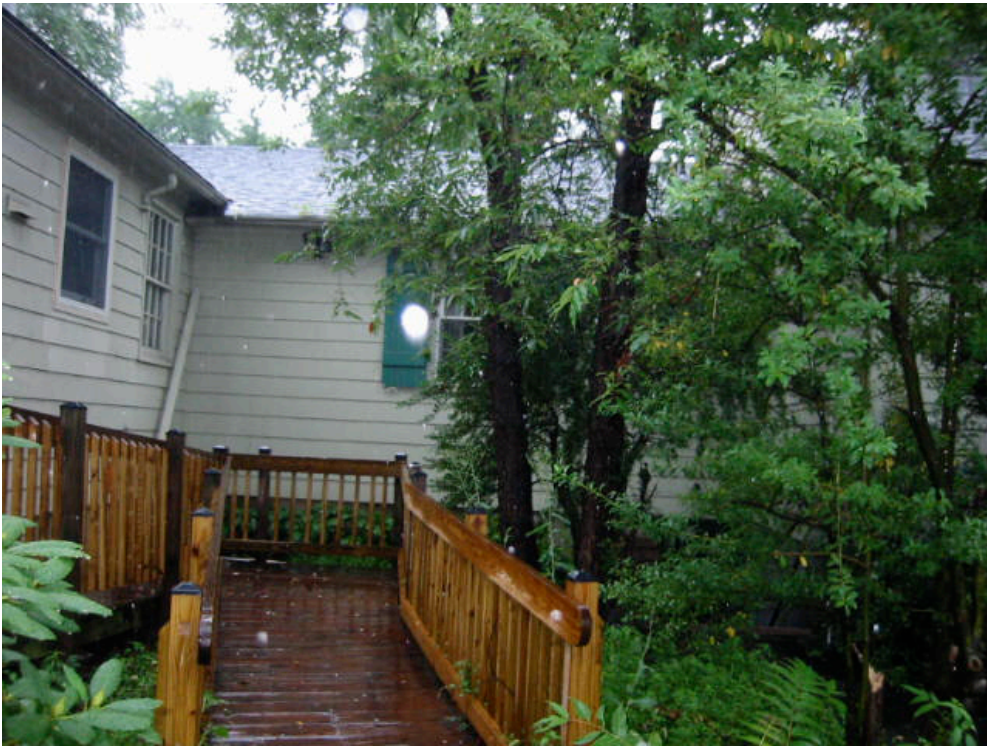
Photograph #5: This wood accessible ramp leads to the raised patio shown in Photograph #4. It is constructed abutting the North Elevation of the Parish Hall. The link that connects the Parish Hall with the Stevens Wing addition is visible behind the railing. In the far corner of the Parish Hall north facing wall there is an original double hung 8 over 8 wood window. The replacement window to the left of this window is shorter and new shingles are used to infill beneath the window.

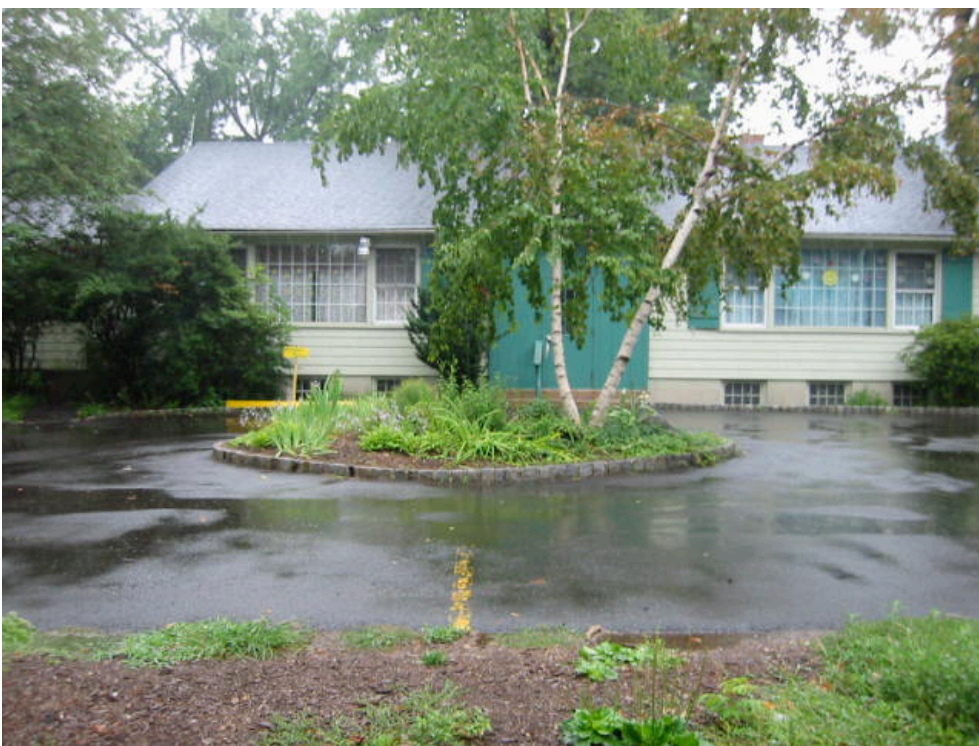
Photograph #6: East facing elevation of the Stevens Wing constructed in 1958. This is the entrance to the Day Care Center. It also shows the relationship of the basement windows to grade. Also notable in this photograph is the oval-shaped driveway with the center planted area.

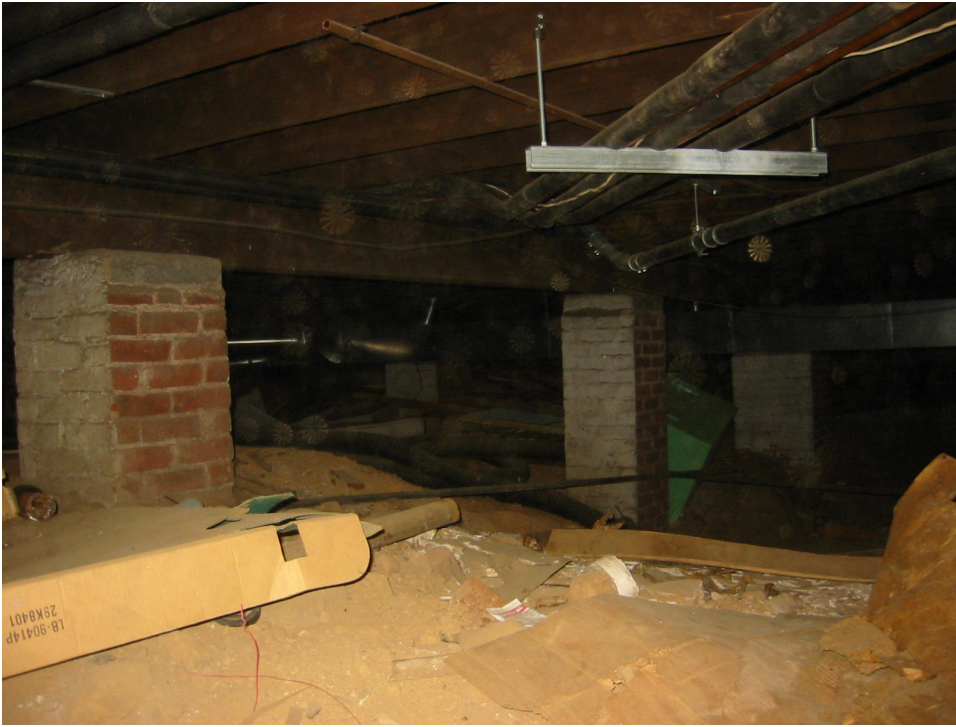
Photograph #7: The basement area at the west end of the Church, looking southeast. There is debris and miscellaneous trash throughout. This condition poses a fire hazard and should be remediated as soon as possible.

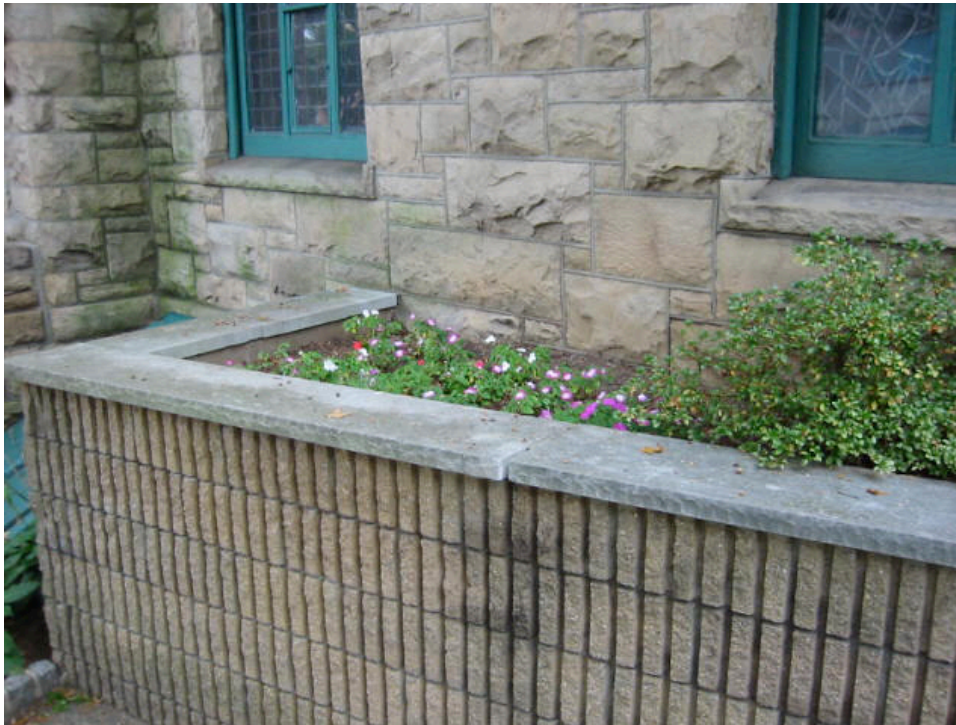
Photograph #8: The raised concrete planter box abuts the north stone wall of the Church at the raised Powell Terrace and entrance to the Parish Hall. This creates a detrimental condition for the masonry and foundation beneath of the masonry wall. Moisture is trapped in the planter and percolates to the interior faces of the basement wall, where a significant amount of stone and brick deterioration was observed.

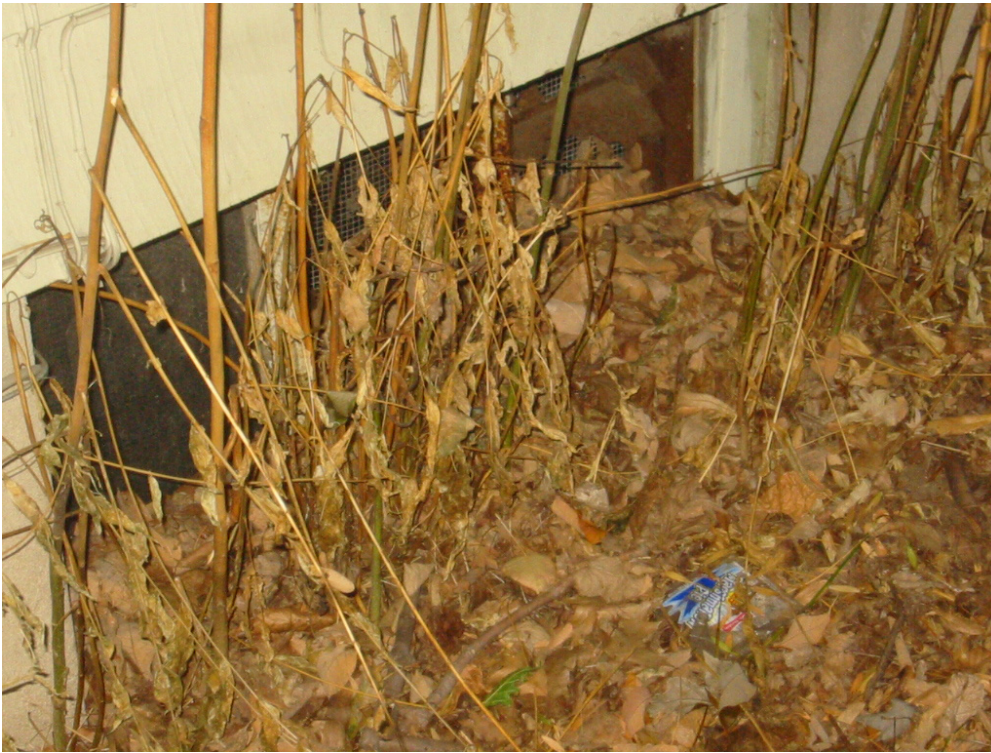
Photograph #9: Plants and weeds are growing too close to the building, creating wet conditions at the foundation walls of the Stevens Wing, as well as soil and vegetation build up. Although the basement window is boarded up, water continues to penetrate the window opening because the grade has been raised due to lack of vegetation maintenance and cleaning.

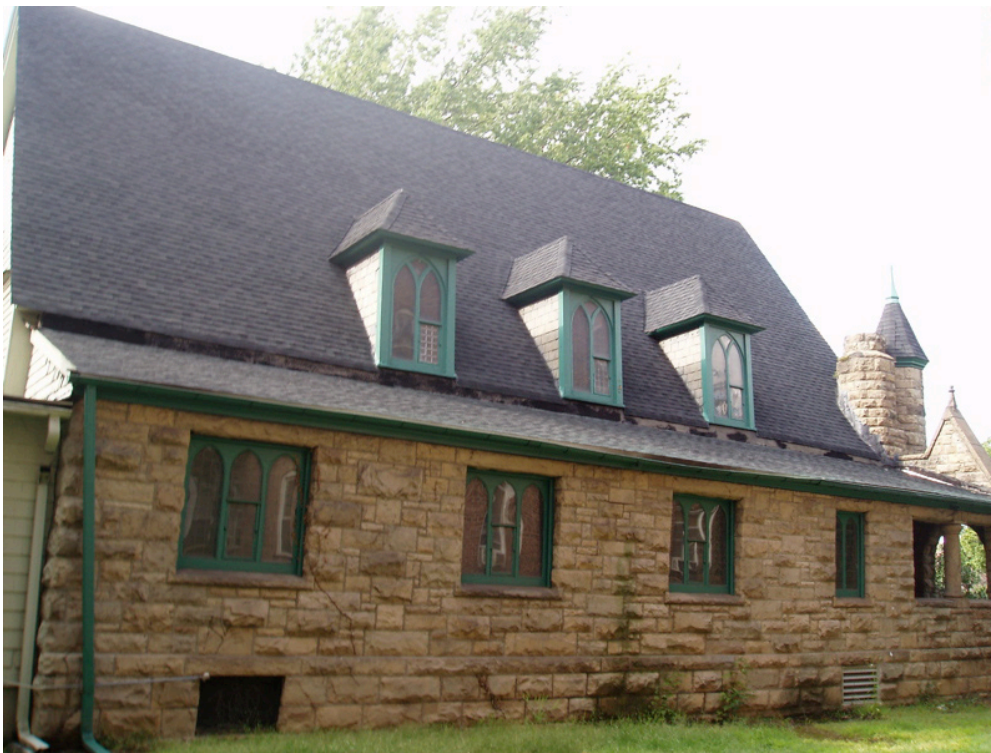
Photograph #10: Missing downspout and bent and broken gutters along the South Elevation of the Church has resulted in biological growth on the stone wall. In addition, there is ponding at grade and water damage along the base of the stone wall with water ingress into the basement resulting in deteriorated mortar.

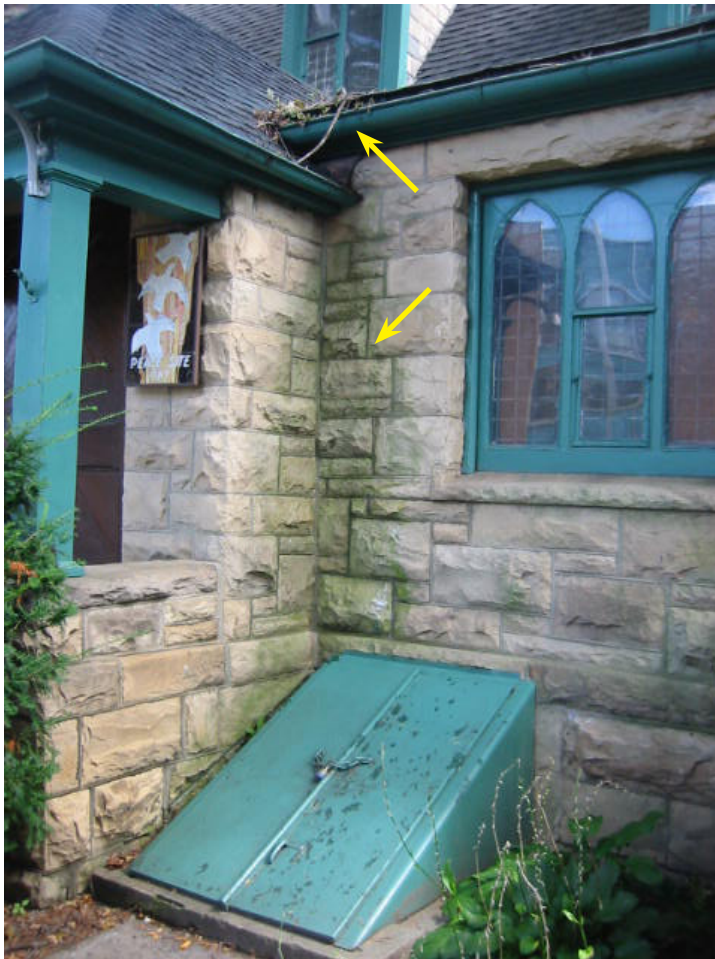
Photograph #11: The basement access hatch adjacent to the North Porch entrance to the Church. There is a large amount of biological growth on the stone at this location. Where the Church roof and the porch roof adjoin there is no downspout and the gutters are blocked with leaves and debris resulting in saturation of the stone wall below. Moisture saturation was also observed in the basement. See Photograph #12.

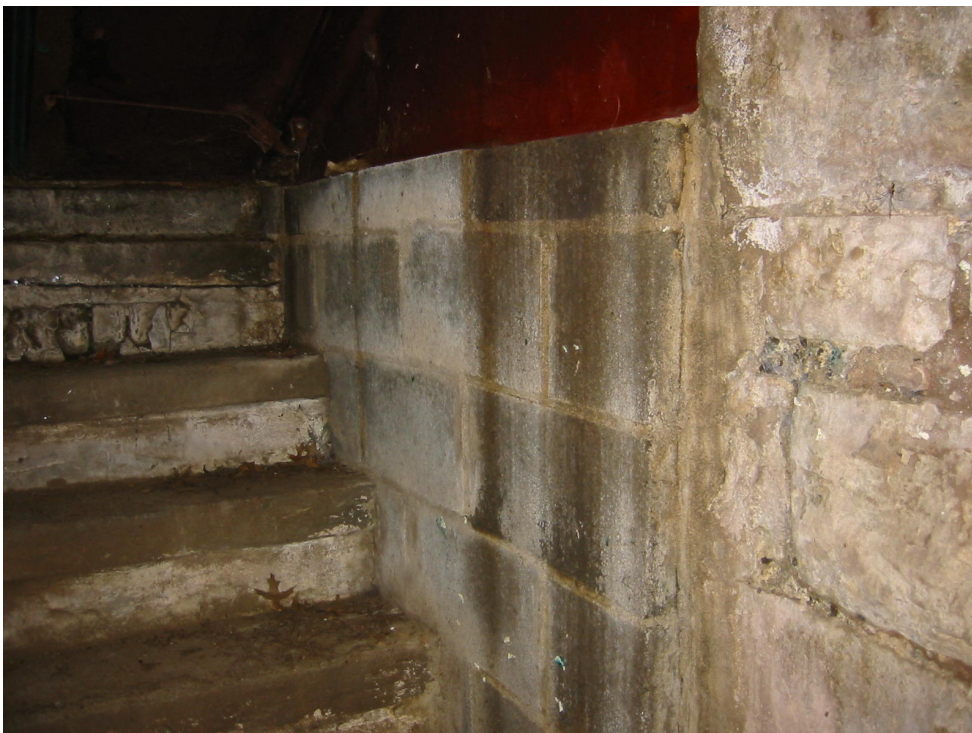
Photograph #12: Steps leading into the Church basement at the basement access hatch. The CMU wall on the east side of the stairs has water staining. The weather tight junction between the North Porch and Basement Hatch has failed.

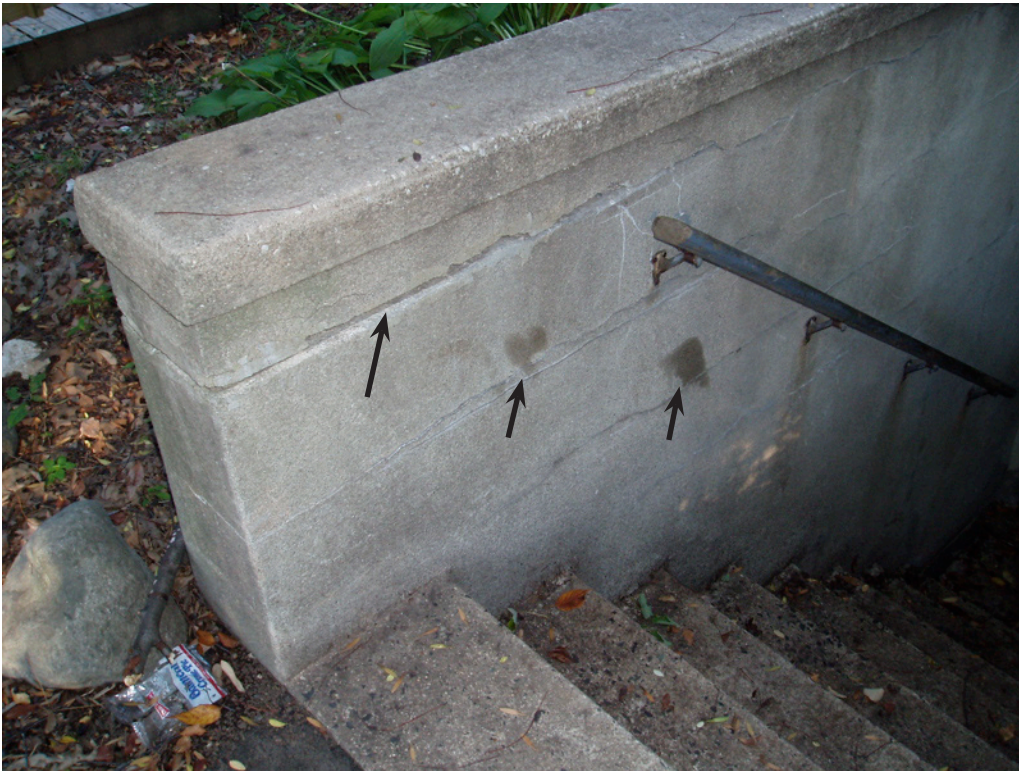
Photograph #13: The stair leading to the basement at the Stevens Wing is located at the southeast corner of this Wing and adjacent to the link. The concrete masonry wall has numerous horizontal cracks with stains from moisture penetration through the walls below grade.

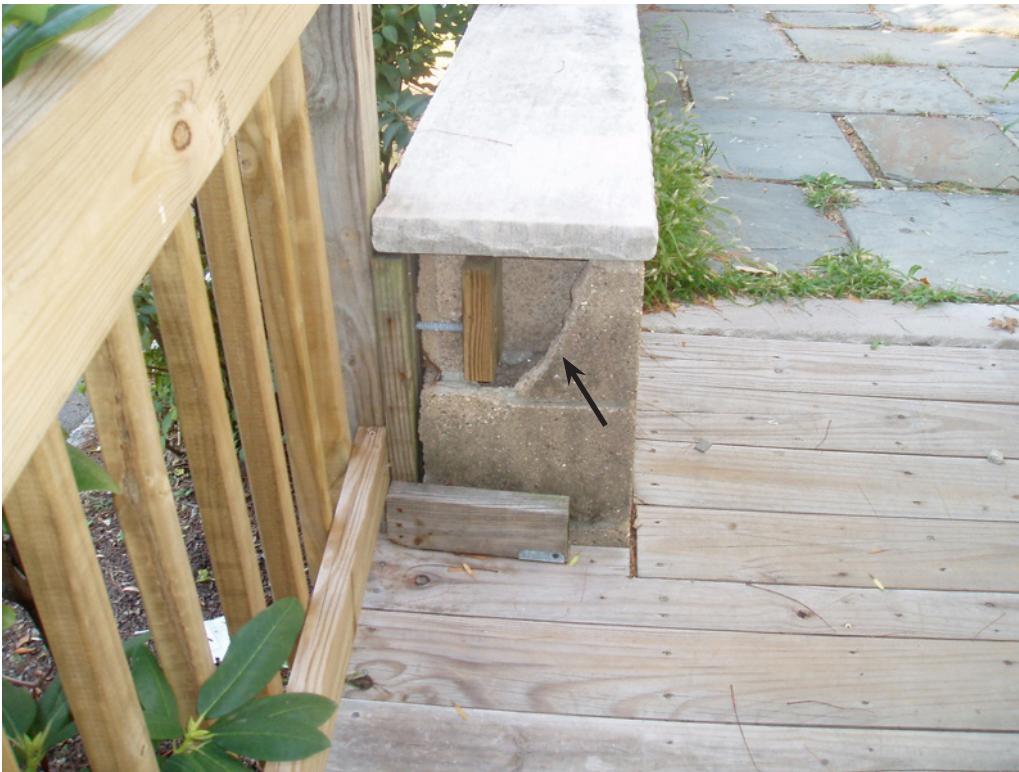
Photograph #14: The ramp on the north elevation of the Parish Hall. The concrete masonry unit wall is failing. This is the North Wall of the east facing Powell Terrace. The Bluestone Terrace is uneven with plant growth at failed mortar joints.

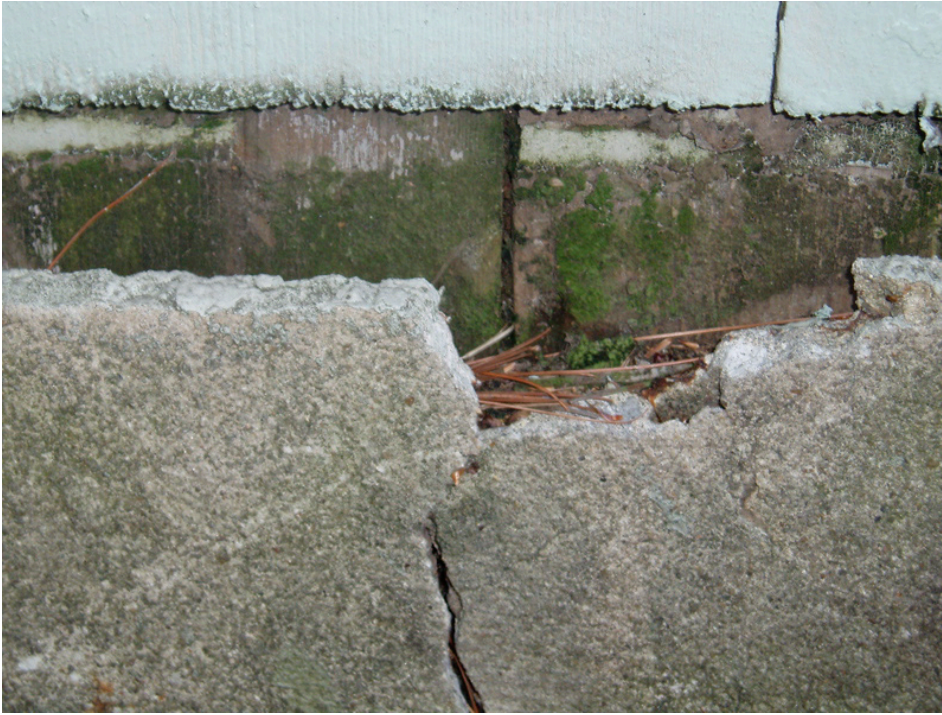
Photograph #15: Contemporary hard concrete parging that has covered the brick foundation wall and some wood siding of the Parish Hall along the North Wall. The parging covers the bottom row of shingles, as well as the brick foundation. Note also that the parging is cracked and spalled at this location.

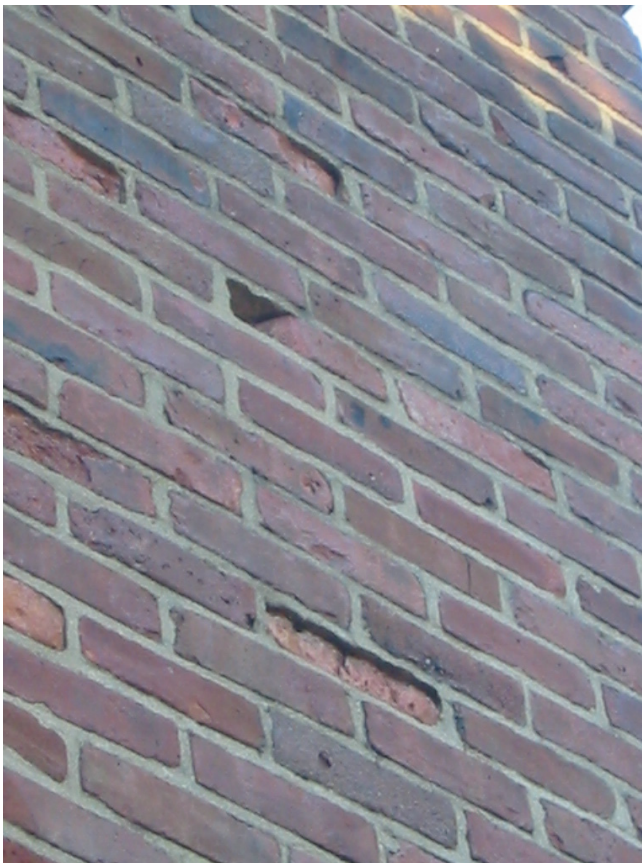
Photograph #16: West face of brick chimney at the Stevens Wing. The significant brick failure due, in part, to poor quality brick material, as well as the use of inappropriate cementitious mortar that is too hard for the brick has resulted in brick failure during freeze thaw cycles.

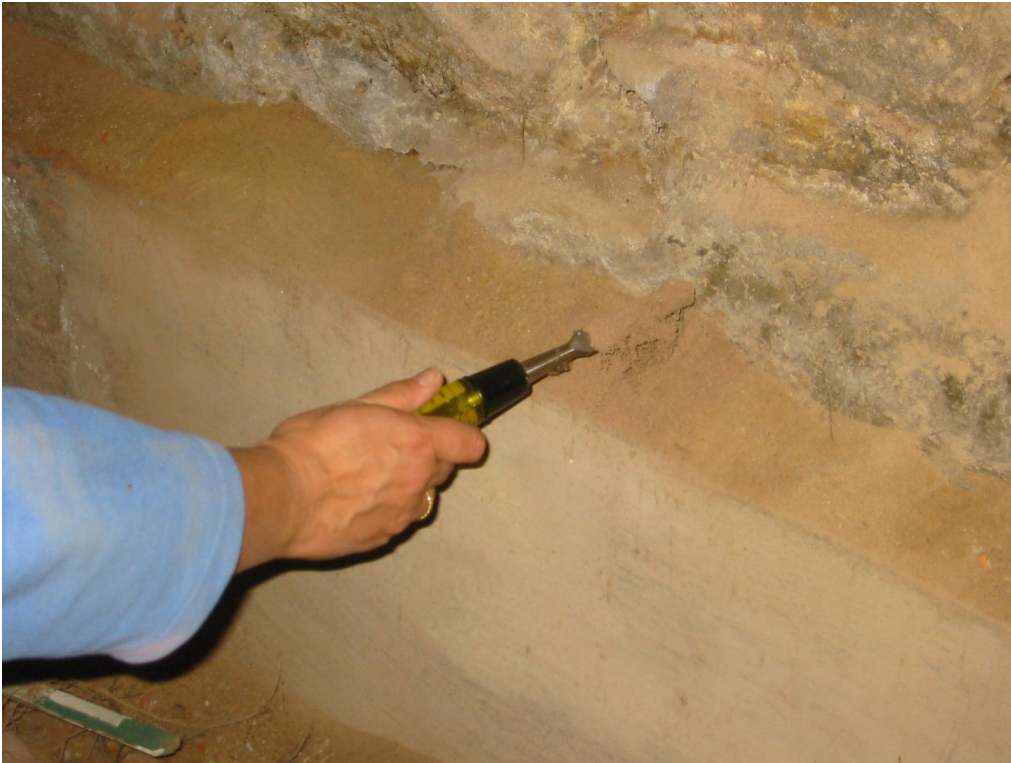
Photograph #17 and #18: These photographs show the large quantity of brick dust along the north basement wall in the Church. This is especially evident beneath the basement window that is blocked by the raised masonry terrace and planter box constructed as part of the Powell Terrace. The brick and mortar debris is coming from the brick arch above the blocked basement window (bottom photo) and the brick foundation walls. The trapped moisture in this area has caused both the mortar and the brick to deteriorate. Refer to Photograph #8 for exterior conditions.

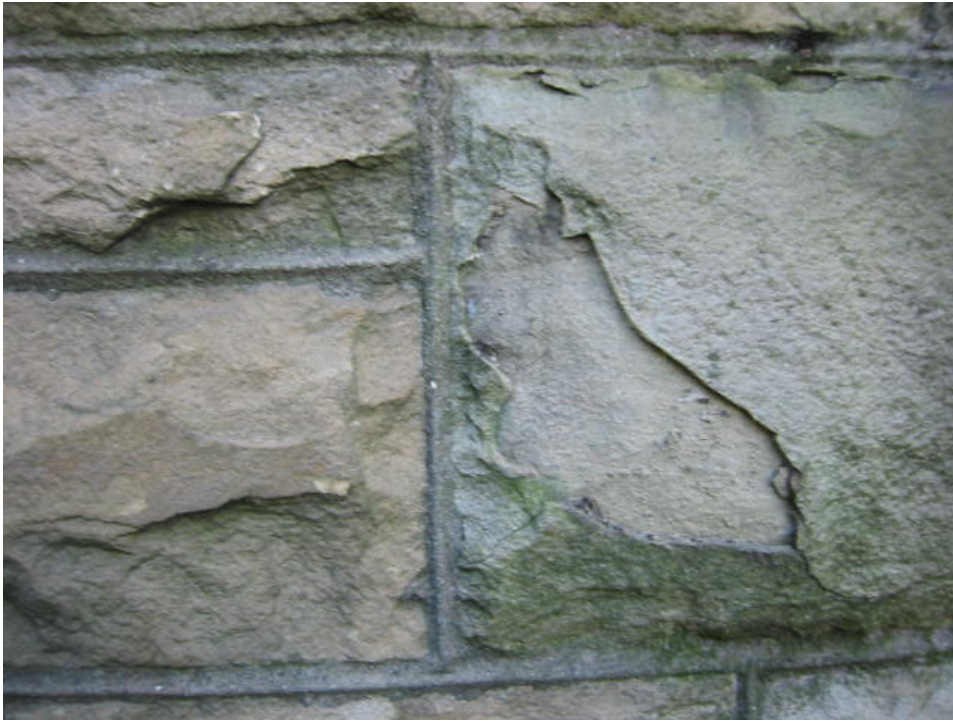
Photograph #19: The Church stone showing exfoliation of the stone surface. The hard, cementitious repointing mortar with a beaded joint profile traps moisture, which then freezes causing the stone surface to spall and fail. The mortar is completely intact because of its high strength.

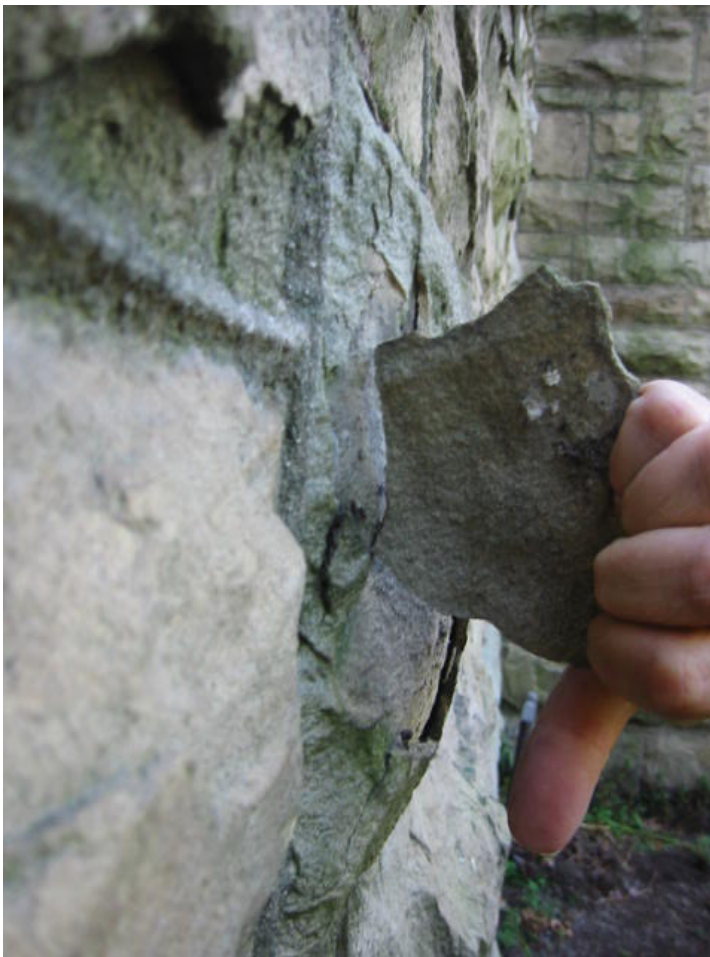
Photograph #20: The rock-faced finish of the stone projects enough so that the surface loss has not impacted the stability of the stone but made it more vulnerable to moisture exposure. This is further exacerbated by stones laid incorrectly with a vertical bedding plane resulting in increased failure. This condition could be hazardous if large pieces of stone face fall from high levels.

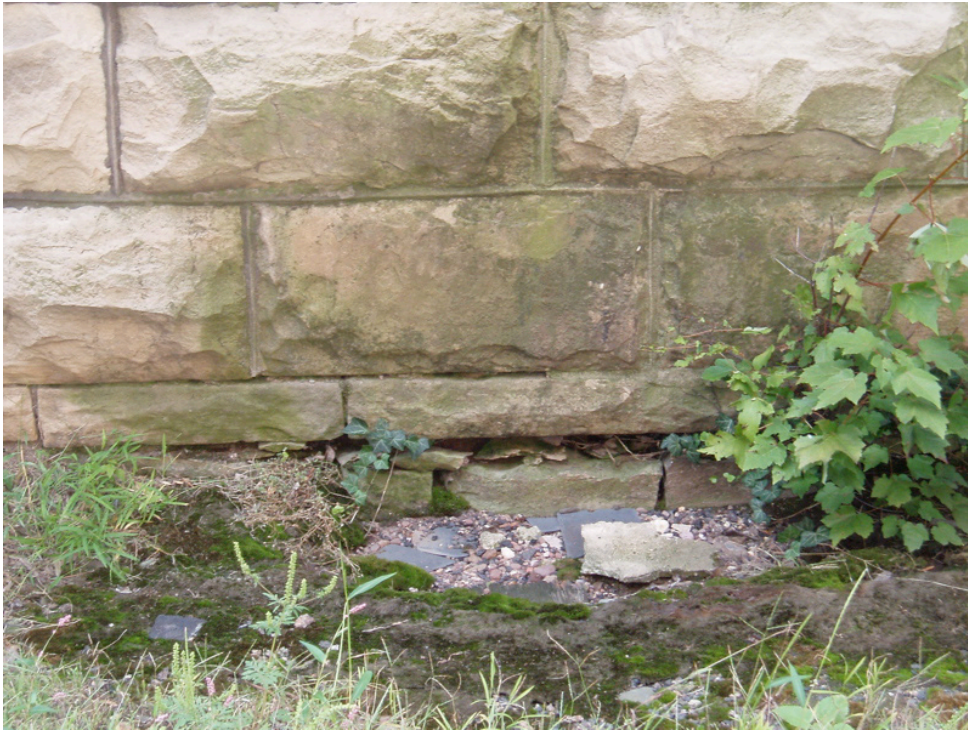
Photograph #21: Detail at the base of the South Elevation of the Church showing the open mortar joints, and cracked and spalled stones that have resulted from the water ponding in this area where downspouts above have failed.

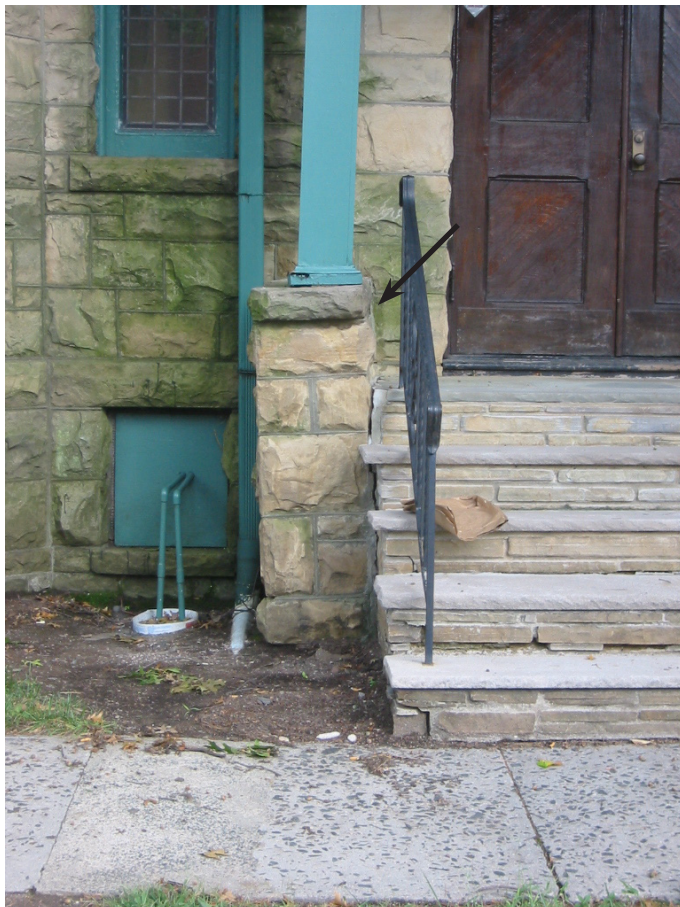
Photograph #22: This is the North Porch entrance to the Church. The displacement of the stone wall supporting the porch roof above is significant. The steps have been rebuilt and the masonry is failing especially at the new risers. The steps have a contemporary metal handrail, which does not meet current code safety requirements.

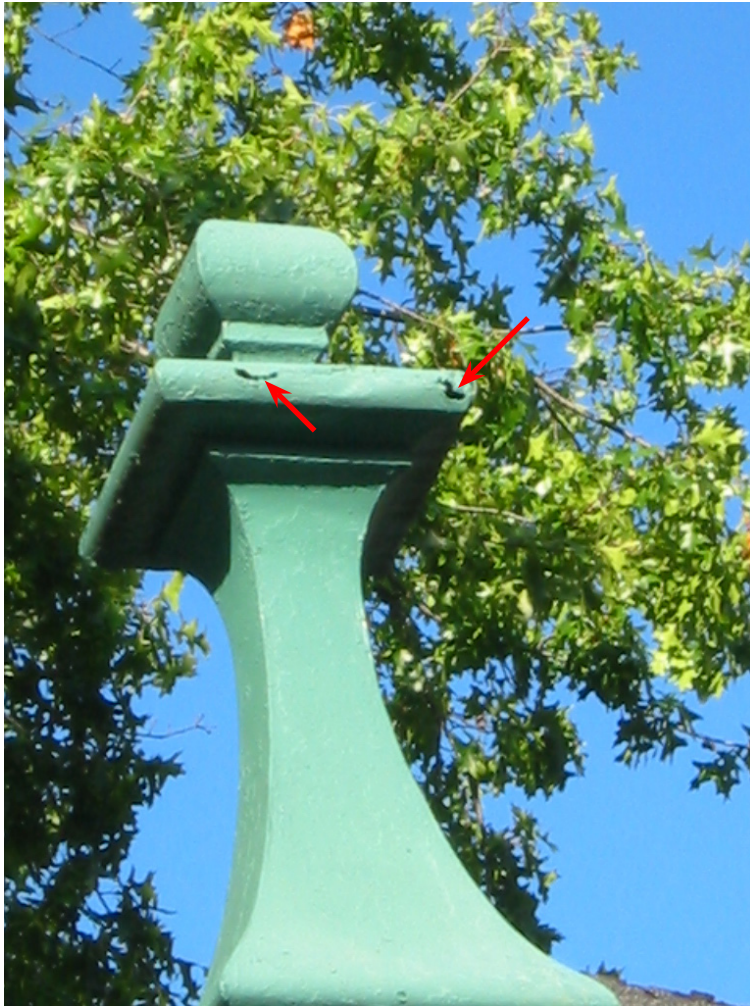
Photograph #23: Detail of metal finial at one of the dormers on the Church. Several finials are missing. Holes in the metal indicate severe corrosion, which is currently covered with what appears to be fairly recent paint.

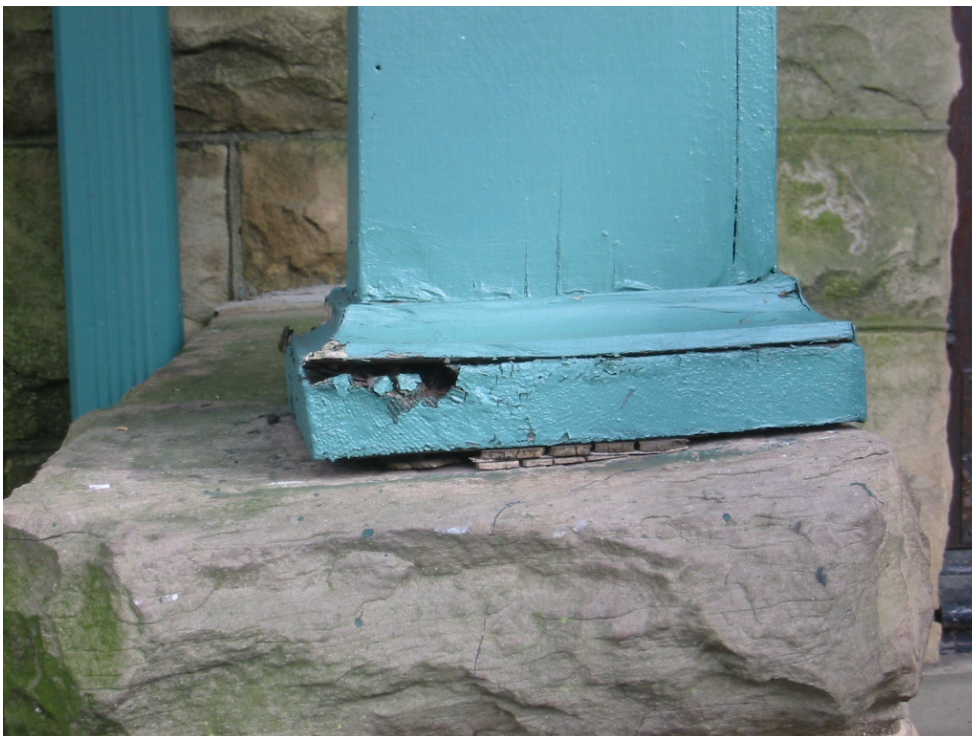
Photograph #24: Woodwork at North Porch on the Church. The deteriorated wood post base has some significant rot. The wall below is leaning to the east. See Photograph #17.

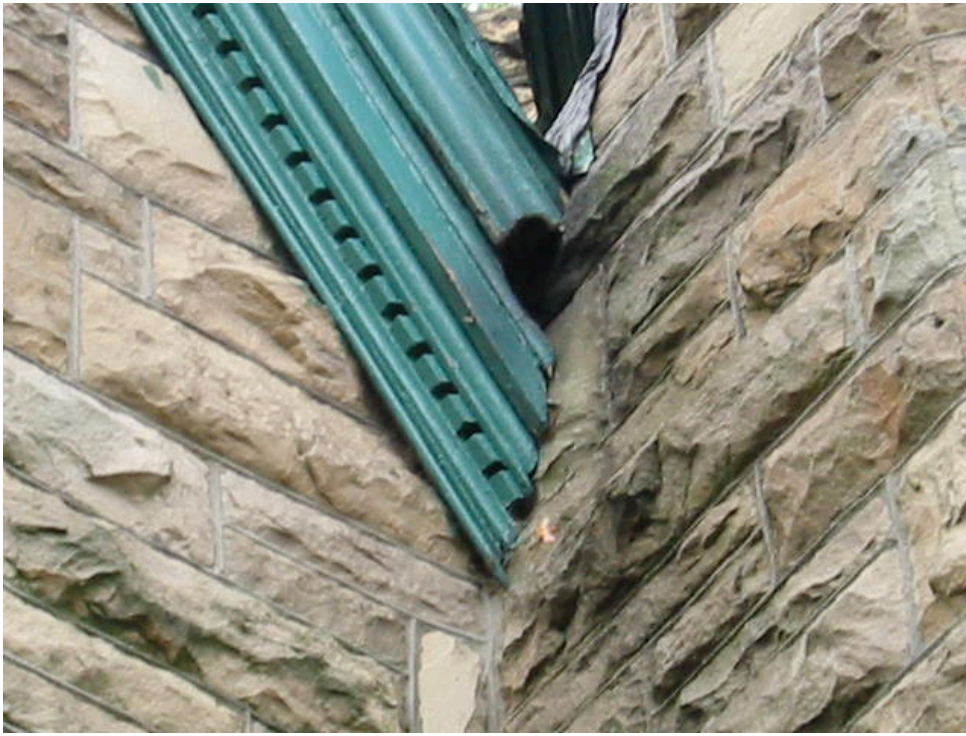
Photograph #25: Detail at molded rake board with dentils on the east gable elevation of the Church. The hole is probably a result of pest ingress. The wood has heavy paint build up and is vulnerable to rot especially at this location where the lead flashing above appears deteriorated.

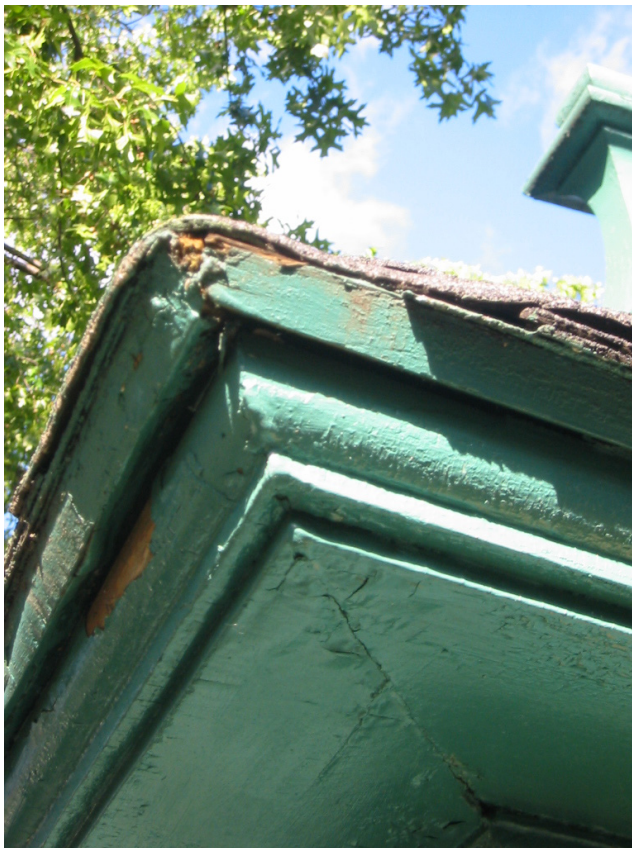
Photograph #26: Close up view of the corner of a window dormer soffit. The asphalt shingle above has failed resulting in wood rot where there is no roof drip edge. All the wood has substantial paint buildup and alligatoring of the surface paint.

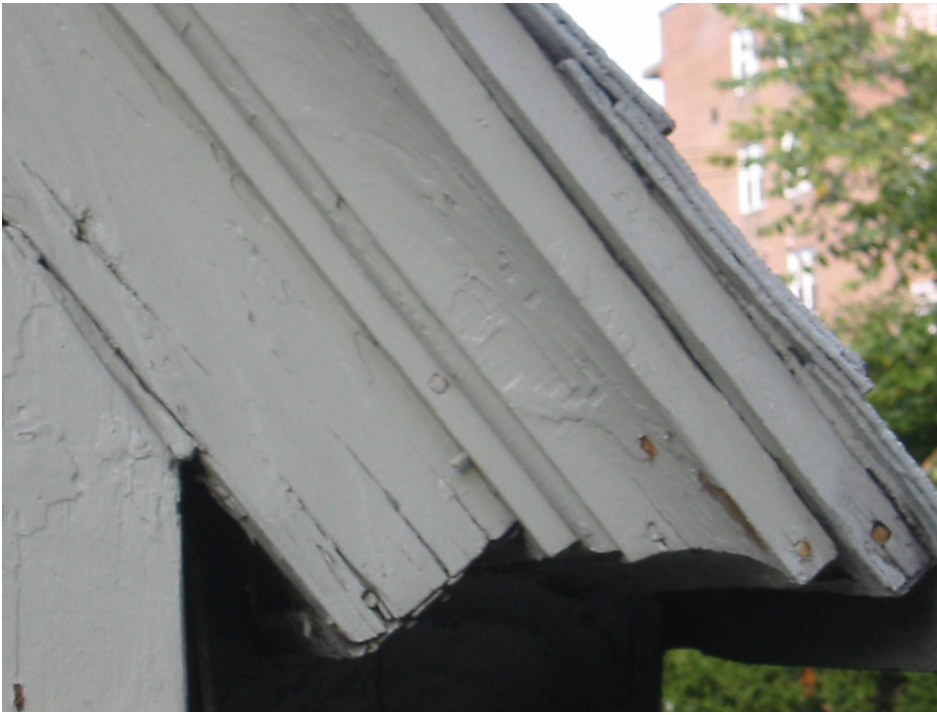
Photograph #27: Molded wood rake board on West Elevation of the Church. The wood is dry and split with heavy paint build up. Many of the nails have corroded, expanded and caused the wood to split. Painting of the trim was completed more recently than the asphalt shingle roof.

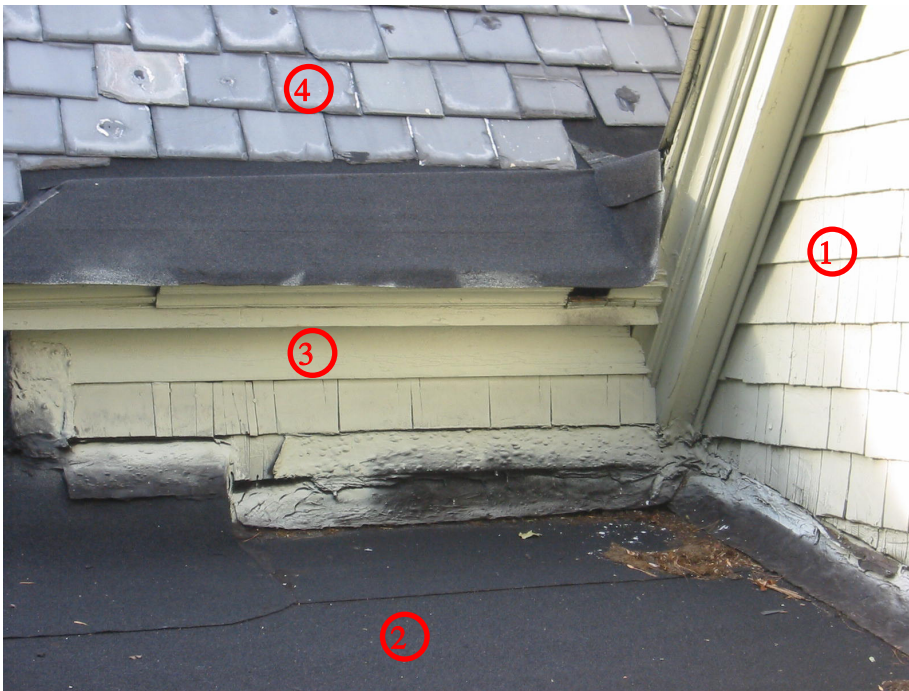
Photograph #28: West Elevation of Church and South Elevation of Parish Hall above the 1947 addition's roof. Three different campaigns of construction can be seen in this location. The rake board and shingles to the right are on the original gable wall of the Church. (#1) The built up flat roof at the bottom of the photograph represents the 1947 addition to the Parish Hall. (#2) The extension to the west of the Church is where the organ was originally housed. (#3) The slate roof on the Parish Hall has severe deterioration with loose slates and punctured slates from improper repairs. (#4) All the roof flashing and built up roofs have been poorly patched and repaired..

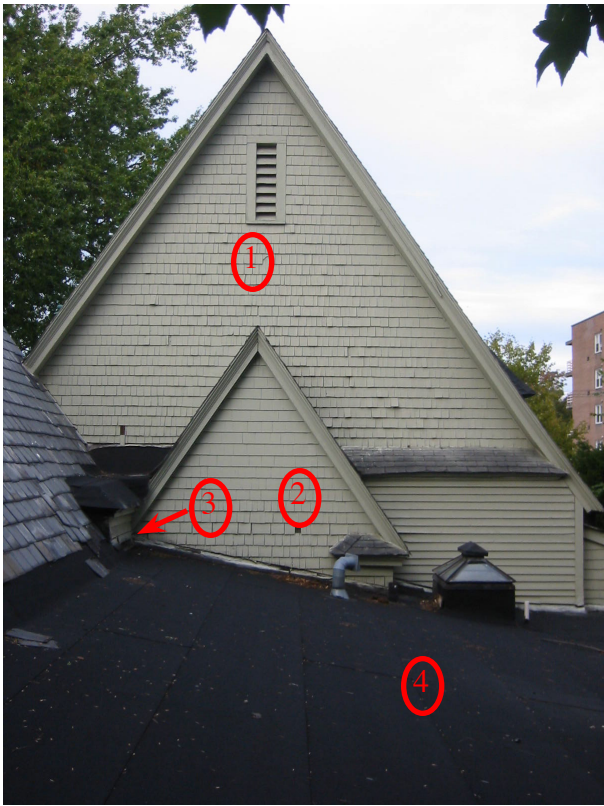
#29

Photographs #29, #30 and # 30A: The gable (#1) is the original back (west) wall of the Church with its lower shed roof where the wall thickens for the stone wall at the first floor level. The lower gable is the original projection of the west end of the Church, where the altar and pulpit were located (#2). The flat roof is the Church extension that housed the organ (#3). The original Church gable roof is intact and visible inside the Parish Hall (Photographs #30 and #30A). The low-sloped roof, in Photograph #29, is the 1947 addition to the Parish Hall (#4).

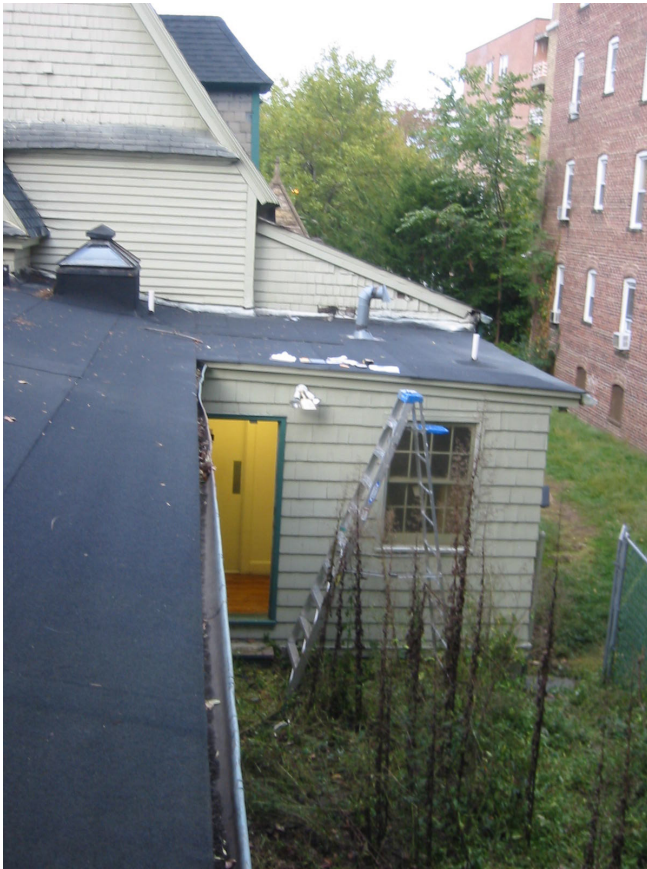
Photograph #31: View of the 1947 addition to the Parish Hall. The roof has a built up roof in fair condition, but the gutters are bent and not draining. The flashing junction between the built up roofs and walls was not repaired when the built up roof was installed and has substantial deterioration. The skylight has some corrosion along the dividing lights.
